# **The Infamous Gusset Plates**

**Roberto Ballarini and Taichiro Okazaki**  
**Department of Civil Engineering**  
**University of Minnesota**

*The City, the River, the Bridge, University of Minnesota Press*

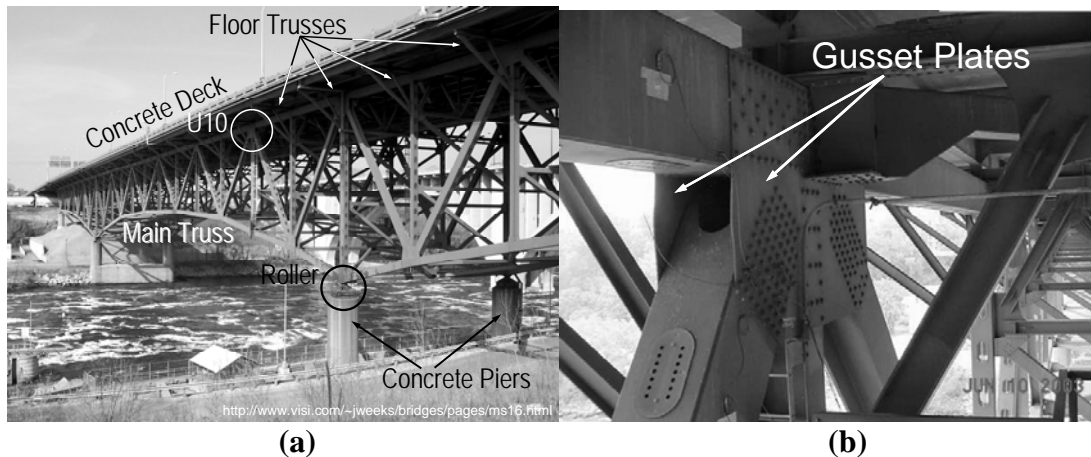
**Figure 1-** (a) Main structural components of the I-35W bridge, photo by John A. Weeks III (<http://www.johnweeks.com/twincities/pages/ms16.html>); (b) Close-up view of the gusset plates at the U10 node from NTSB (*Photos of I-35W Bridge, <http://www.nts.gov/dockets/highway/hwy07mh024/387406.pdf>*).

The main structural components of the bridge and the location of the U10 node that is the focus of this study are highlighted in Figure 1a. Traffic was supported by a

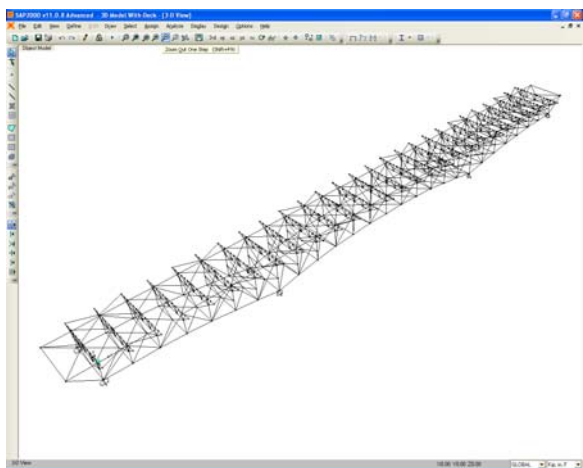
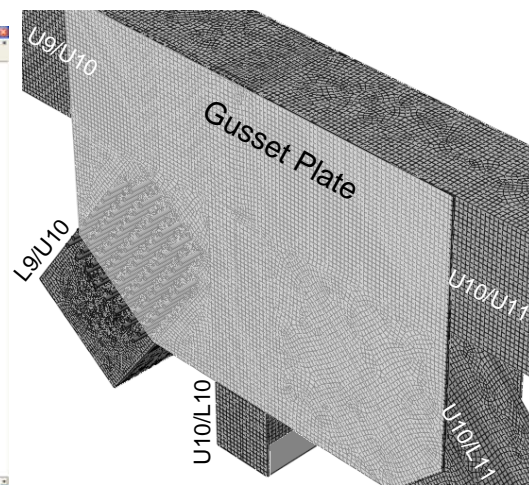
**Figure 2- (a) Computer structural analysis model of the main span of the bridge; (b) detailed finite element (computer) model of the U10 node.**

The forces calculated using the structural analysis model were applied by Minmao Liao to a refined model (Figure 2b) of the connection referred to on the design drawings as node U10, and also indicated in Figure 1a. This connection involves the infamous gusset plates whose failure we determined to have initiated the bridge collapse. The detailed model is referred to as a finite element model because the connection is represented by a very large but finite number of much smaller volume elements. The mechanical behavior of the connection was determined by solving on the supercomputer housed at the Minnesota Supercomputer Institute a very large system of equations obtained by assembling the equations of each volume element.

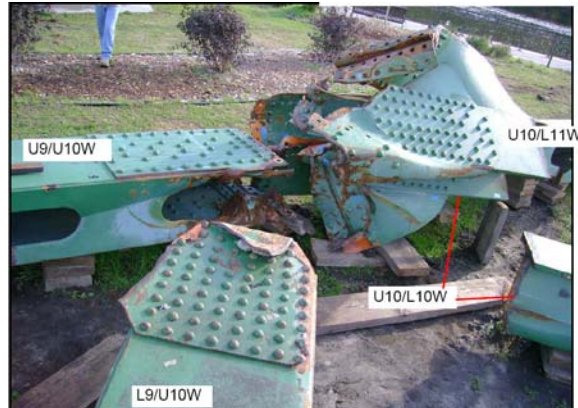
**Figure 4- U10 node after bridge collapse from NTSB (*Photos of I-35W Bridge*)**

A few days after the collapse the NTSB and MnDOT allowed the authors to visit the site of the bridge collapse. What immediately appeared strange was the fact that some of the connections failed, even though (as mentioned previously) they are supposed to be the strong links in the chain defined by the bridge. The post-collapse image shown in Figure 4 suggests that failure of the connection at node U10 was associated with separation between the chord truss member U9/U10W and the diagonal truss member L9/U10W.

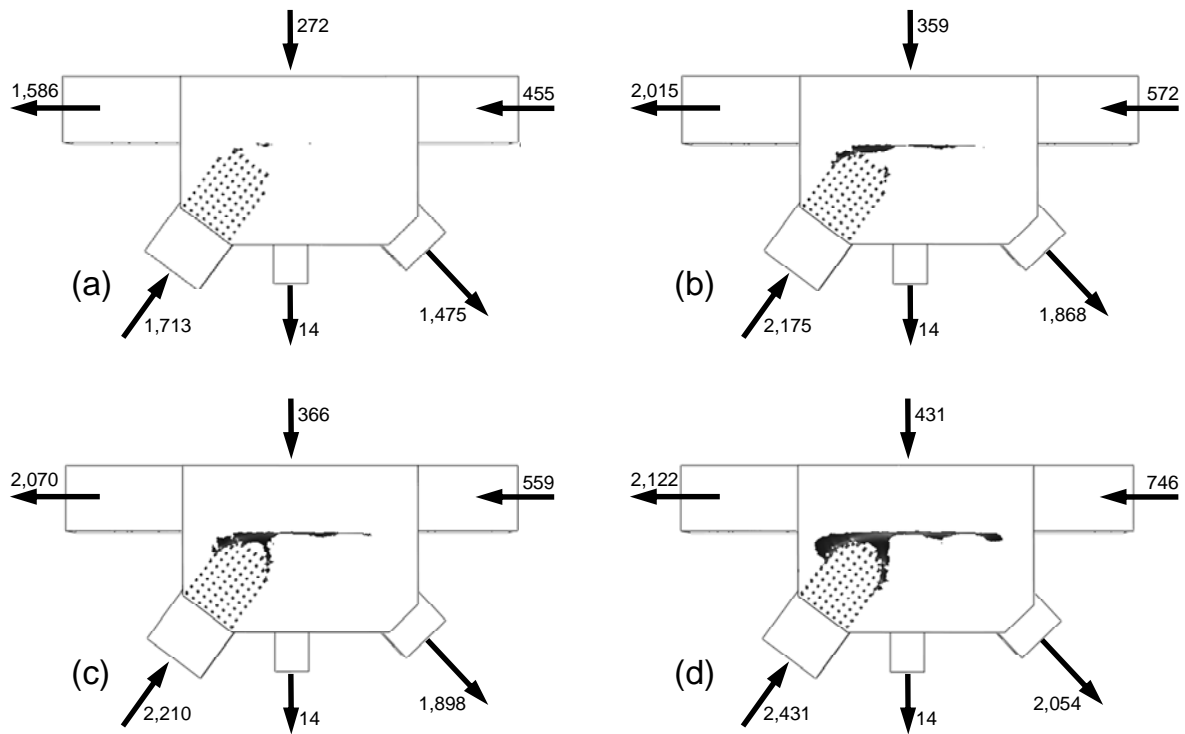
Figure 5a shows that the original weight of the bridge produced forces in the members framing into node U10 in the range of 1,586 kips tension to 1,713 kips compression (1 kip equals 1000 pounds), and that these forces introduced plastic deformation within a small volume within the gusset plate. The condition of the gusset plate is not particularly discernable at this stage.

The addition of 2.0 inches of concrete deck increased the forces in the members by almost 30%, and as shown in Figure 5b this increase extended the plastic deformation across the gusset plate along the top chord. The extent of plastic deformation is beyond what is permitted in allowable stress design. More precisely, these results imply that the

elastic safety factor of the gusset plates at U10 was barely 1.0, while the allowable stress design requires a safety factor of 2.0.

Figure 5c shows the condition produced by adding traffic weight on the day of the bridge collapse. Due to traffic lane closures, the traffic weight was rather light. However, because the gusset plates were substantially yielded under the self-weight of the bridge and the additional concrete, as seen in Figure 5b, even the small load addition produced noticeable extension of plastic deformation. The reason why the extent of plastic deformation increases disproportionately with respect to increased force is because the stiffness of a plasticized steel component is greatly reduced as compared to its elastic stiffness.

The computationally predicted condition of the connection at the instant of bridge collapse is shown in Figure 5d. All load effects, including the self-weight of the bridge, traffic weight, and construction material and equipment placed on the day of bridge collapse, are accounted for. The figure implies that a very substantial portion of the gusset plate was yielded. It is also noted that the pattern of plastic deformation suggests that the gusset plate is approaching a failure corresponding to separations between the horizontal U9/U10W chord and the L9/U10W diagonal, and across the rivet holes on the L9/U10W diagonal. The predicted failure scenario is consistent with the observed failure shown in Figure 4.

**Figure 5- Plastic deformation in gusset plates at U10 resulting from (a) the weight of the bridge at the time of original construction, including all steel and concrete; (b) the addition of 2" of concrete deck in 1977 and 1998; (c) the weight of traffic added; (d) the weight of construction material and equipment added. All forces have units of kips (1000 pounds).**

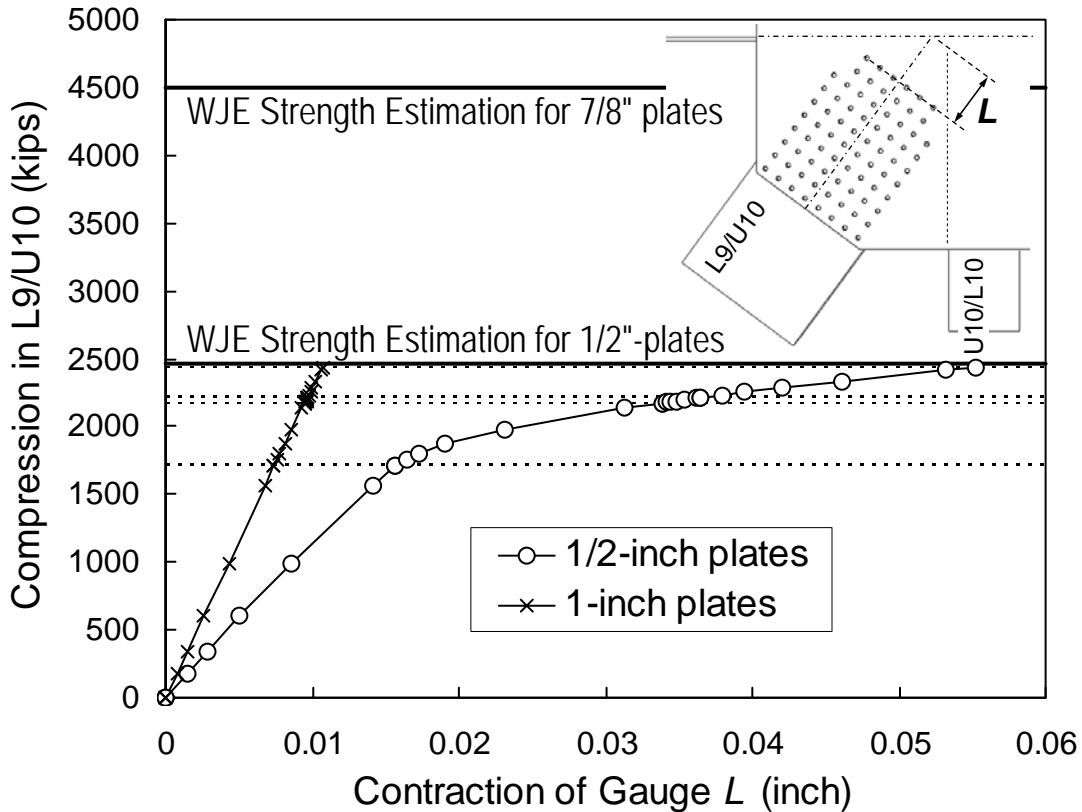
The plot in Figure 6 shows the computed relationship between the compression in the diagonal truss member L9/U10W and contraction of the selected gauge *L*. Two curves are shown, one for the actual U10 gusset plate, and another for a hypothetical gusset plate that is identical to the U10 gusset plate but is 1 inch thick. The four dotted horizontal lines indicate the force levels corresponding to the four stages shown in Figure 5. As the compression was increased from 1,713 kips to 2,431 kips, the response of the ½ inch gusset plate softened. The softening is due to the extension of plastic deformation shown in Figure 5. The curve indicates that the ½ inch thick gusset plate was approaching its capacity limit where the compression in member L9/U10W cannot be increased any further. The capacity limit indicates failure of the gusset plate. Meanwhile, the 1 inch thick gusset plate remains elastic under the forces experienced the day of the collapse; it does not exhibit similar softening behavior. Therefore, Figure 6 indicates that had U10 gusset plates been 1 inch thick instead of ½ inch thick, the tragic bridge collapse would not have happened. We note that the results of this investigation are consistent with those obtained using similar computer modeling by NTSB and WJE. As shown in Figure 6, WJE's prediction of the capacity of the ½ inch gusset plate is practically the same as the capacity predicted by the authors. This figure also shows that WJE predicted that a 7/8 inch thick gusset plate would have had sufficient capacity to resist the forces that existed prior to the collapse.

**Figure 6- Plot of force in the L9/U10W diagonal versus the compression of a selected gauge length at the U10 node, as predicted by the finite element model for the ½ inch gusset plate and for a 1 inch thick gusset plate. Also shown on the figure are the capacity of the gusset plates at U10 predicted by the finite element model of WJE and the capacity that would have been achieved by a 7/8 inch thick gusset plate.**
