Research Paper

Mechanical assessment of grit blasting surface treatments of dental implants

K. Shemtov-Yona*, D. Rittel, A. Dorogoy

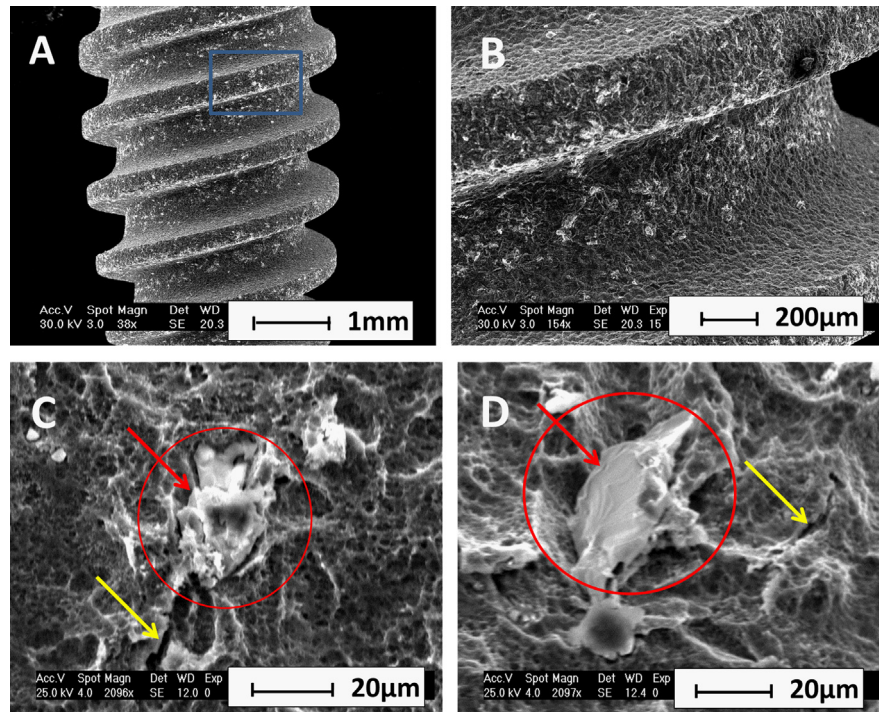
At small magnification (Fig. 4A), one can note that the implant's surface is rough, as expected for improved osseointegration. However, large areas are covered by small white particles. Fig. 4B, confirms the previous observations at higher magnification. The surface is irregular and rough with large crater-like areas, with sharp edges that result of plastic deformation and material tearing. Micro-holes (pit-like surface topography) are present in those craters, which are characteristic of the acid etching surface treatment (Fig. 4C and D). Embedded particles with different sizes and shapes are scattered randomly all over the surface. Note that the implants usually undergo a cleaning procedure after the grit-blasting process, so that the observed particles survived the treatment, implying a firm bonding to the substrate. Fig. 4C and D shows that these particles, marked by red arrows, are attached to the crater like morphology that they have created. Fine small cracks $15\text{--}25 \mu\text{m}$ long (yellow arrows), which were generated in the vicinity of the particles, are observed.

Fig. 4 – SEM macrograph of the tested commercial implants. A: Implant threads macrograph B: implant surface macrograph – the macrograph is a magnification of the area marked by a blue square on A. C and D: Embedded particle (red arrow) in a crater like area (red circle) with small cracks (yellow arrow) on the implant surface. (For interpretation of the references to color in this figure legend, the reader is referred to the web version of this article).

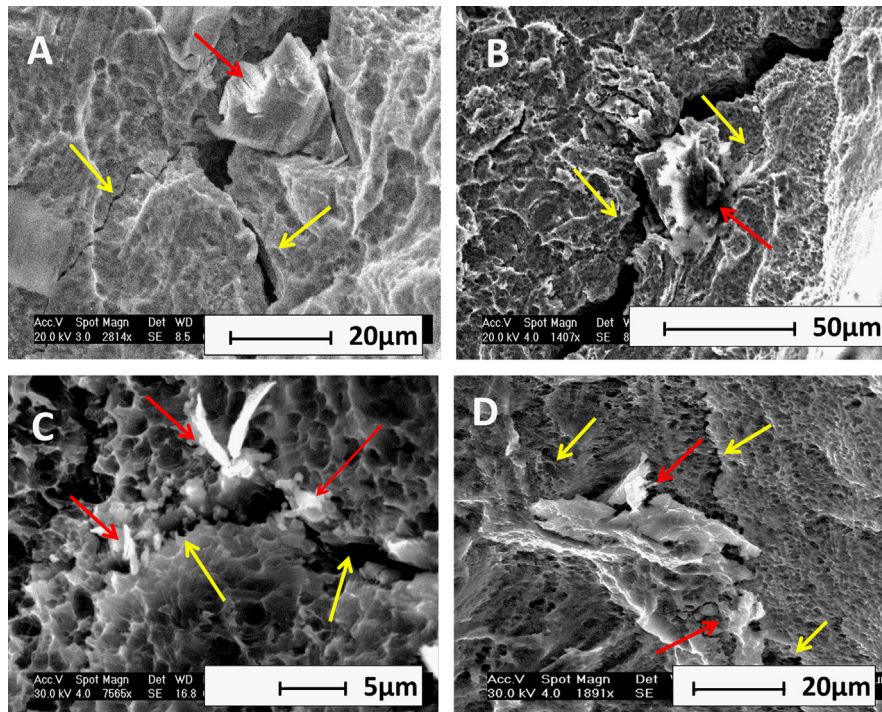
Fig. 5 is a SEM surface micrograph of cracks observed on specimen #3 after 3 check-points (15,000 cycles) *before the final fracture*. Such micrographs are representative of all the tested

specimens. In all cases, a large main crack was identified. The crack was located between the second and third threads of the implant. Fig. 5A–D shows details of that crack. Lateral secondary cracks, branched from the large main crack, can be identified (Fig. 5 yellow arrows). In addition, Fig. 5A D shows that large and small embedded particles (red arrows) are located along the cracks paths, and probably dictated it.

Fig. 5 – A–D: SEM micrograph of crack identification on fatigue tested specimen 3 before the final failure. On each micrograph the large main cracks and lateral secondary cracks can be identified (yellow arrows) embedded along the cracks are ceramic particles (red arrows). (For interpretation of the references to color in this figure legend, the reader is referred to the web version of this article).

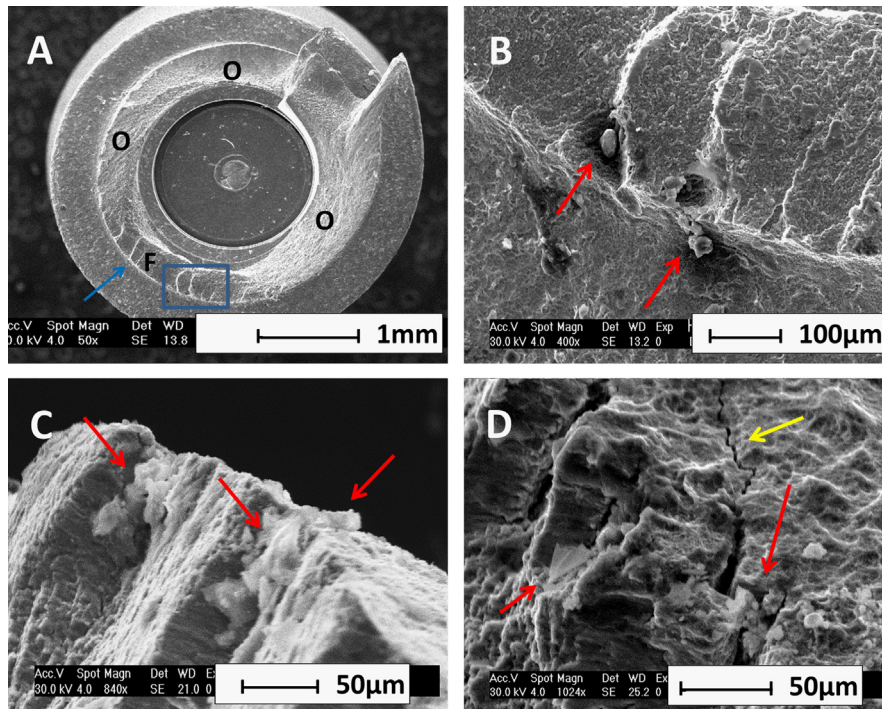
Next, we examined the fracture surface of specimen #3 *after final fracture*. Two regions can be identified. The main region is rough with sharp edges that fill about 90% of the fracture surface (Fig. 6A letter O). This region correspond the ductile overload failure, with dimples (Kerlins and Phillips, 1987) at magnification of 1K (not shown in the figure). The second region is flat and fills only 10% of the fracture surface (Fig. 6A letter F). This region corresponds to the fatigue failure process with its classical striations (Kerlins and Phillips, 1987), at magnification of 7K (not shown in the figure). The fatigue crack initiation site is marked by blue arrow on the fractograph, as identified from the array of steps (outlined by a

Fig. 6 – Fracture surface of fatigue tested implant after final fracture. A: The fracture surface with flat part caused by fatigue failure mechanism marked by the letter “F” with crack initiation location (Blue arrow) and rough part marked by the letter “O” B: Upper view of crack initiation location – the macrograph is an enlargement of the area marked by a blue square on A with embedded particles marked by red arrows C: Side view of crack initiation location with embedded particles marked by red arrows. D: Side view: secondary cracks, marked by yellow arrows, on the lateral view, at the vicinity of the fracture surface with embedded particles along the crack, marked by red arrow. (For interpretation of the references to color in this figure legend, the reader is referred to the web version of this article).

rectangle in Fig. 6A). This region is magnified in Fig. 6B. The presence of foreign particles (red arrows) embedded in, or close to the steps is clearly visible.

Looking at the outer face of each staircase from the surface side (side view), shows again embedded particles (Fig. 6C red arrows). All the above fractographic evidence suggests that the ceramic particles are related to the cracks nucleation sites, leading to final fracture. Lateral secondary cracks can be identified on side views of the implant surface, near the outer face of the fracture surface, (Fig. 6D yellow arrows) with embedded particles (Fig. 6D red arrows).

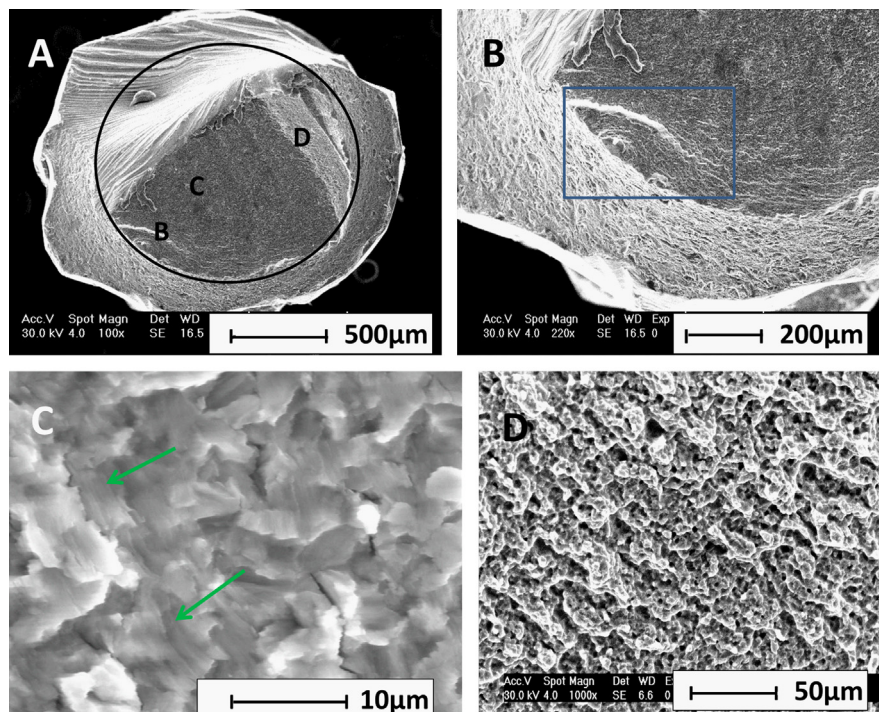
Fig. 7 (Ti-6Al-4V) and 8 (CP-Ti) show typical fractographs obtained during the failure analysis that was carried out in order to identify the failure mechanism(s). The fracture surfaces are all outlined by a circle. The fracture surface can be divided into two regions, as was observed for the laboratory specimens. The main part is flat and unified in appearance and occupies roughly 90% of the fracture surface. The second region is rough with sharp edges over the remaining 10% of the fracture surface. The operating failure mechanism in the first region is identified as (ductile) monotonic overload, as evidenced from the dimples observed in this region (Figs. 7D and 8D).

On the fracture surface of retrieved fractured CP-Ti and Ti-6Al-4V dental implants, parallel lines were identified and marked by the letter B in Figs. 7A and 8A. Those parallel lines

can be seen at higher magnification in Figs. 7B and 8B. Such lines are identical in nature to those identified on the fracture surfaces of the laboratory fatigue tested implants (Fig. 6A and B). Consequently, those features point to the origin of the fatigue crack, i.e. the onset of the implant's failure process (Figs. 7B and 8B). In this case too, the lines originate from the free surface of the implants.

The rough part of the fracture surface marked by the letter D on Figs. 7A and 8A is characteristic of monotonic ductile overload failure (Kerlins and Phillips, 1987).

Fig. 7 – Failure analysis of retrieved fractured Ti-6Al-4V dental implants with representative fractographs A: The fracture surface marked by round circle. The letters on the fracture surface are the locations on the fracture surface of fractographs B, C and D. B: fractograph of crack initiation location (Blue square) (X220). C: fractograph of fatigue crack propagation: fatigue striations are marked by green arrows (8 K) on the flat part. D: final failure markings, dimples on the rough part. (For interpretation of the references to color in this figure legend, the reader is referred to the web version of this article).

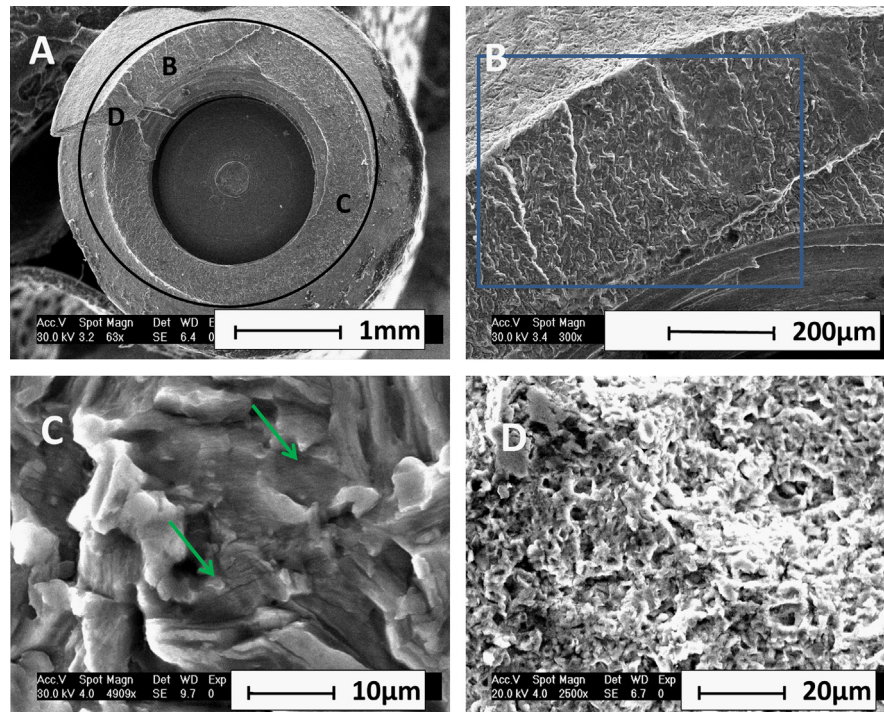
Fractographic examination of the flat region, for every examined retrieved dental implant, clearly reveals the operation of a *fatigue fracture mechanism*. Faint fatigue striations (Kerlins and Phillips, 1987; Shemtov-Yona et al., 2014b) are observed on the retrieved Ti-6Al-4V dental implants when high magnification of 10K is used (Fig. 7C green arrow). These fatigue striations were identical to the fatigue markings seen on the specimen fractured in lab conditions. Likewise, clear fatigue striations are visible on the retrieved CP-Ti dental implants when a magnification of 6K or more is used (Fig. 8C, green arrow).

Fig. 8 – Failure analysis of retrieved fractured CP-Ti dental implants with representative fractographs A: The fracture surface marked by round circle. The letters on the fracture surface are the locations on the fracture surface of fractographs B, C, and D. B: fractograph of crack initiation location. Parallel line marked by a blue square on the flat part. C: fractograph of fatigue crack propagation: fatigue striations are marked by green arrows on the flat part. D: final failure markings, dimples on the rough part. (For interpretation of the references to color in this figure legend, the reader is referred to the web version of this article).

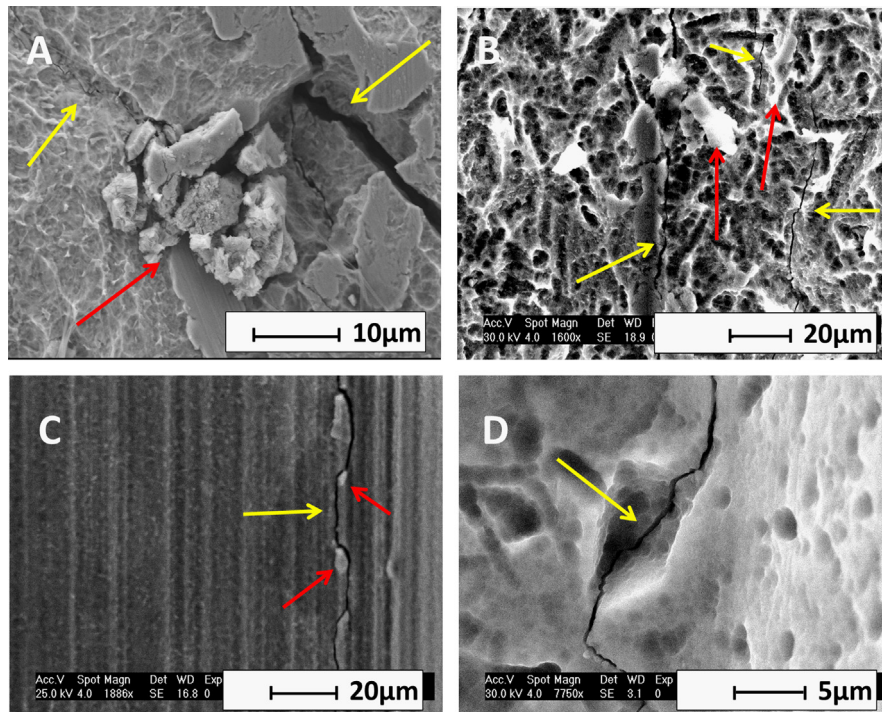
Ti-6Al-4V (Fig. 9 A and B) and CP-Ti (Fig. 9C and D). These micrographs are taken from the threaded part of the implant's body.

SEM micrographs of the secondary cracks in several retrieved Ti-6Al-4V and CP-Ti implants, show embedded foreign particles (Fig. 9 red arrows). EDX analysis of the embedded particles on the path of the secondary cracks reveals that these particles are made of Al_2O_3 and/or FeO. Judging from the overall secondary crack path, it appears that the embedded particles affect the secondary crack path itself.

Fig. 9 – surface micrographs A and B: micrograph from Ti-6Al-4V implant's surface that were grit blasted and acid etched with secondary cracks (yellow arrow) with embedded ceramic particles along the secondary cracks path (red arrow). C: micrograph from machined implant surface with secondary cracks (yellow arrow) with embedded particles caused by machining. D: micrograph from implant surface with secondary cracks (yellow arrow) with deep craters generated by the surface treatment. The secondary crack passes through the deep crater. (For interpretation of the references to color in this figure legend, the reader is referred to the web version of this article).

Considering the nature of the imparted damage, SEM observations clearly showed the presence of embedded ceramic particles on the implants' surface. During the fabrication process of the implants these particles should be removed either by chemical treatments done according to the ISO recommendations (ISO B600, 2007; ISO F86, 2007), or during the etching surface treatments done using a strong acid. The very fact that these particles remained embedded to the surface, whether intact or shattered indicates that these particles have adhered to the surface as a result of the aggressive surface treatment. In that case too, the numerical simulations show that for a certain velocity, the surface temperature can approach or even exceed the melting temperature of the surface, thereby apparently promoting a strong particle-substrate adhesion process.
