Research Paper

Mechanical assessment of grit blasting surface treatments of dental implants

K. Shemtov-Yona*, D. Rittel, A. Dorogoy

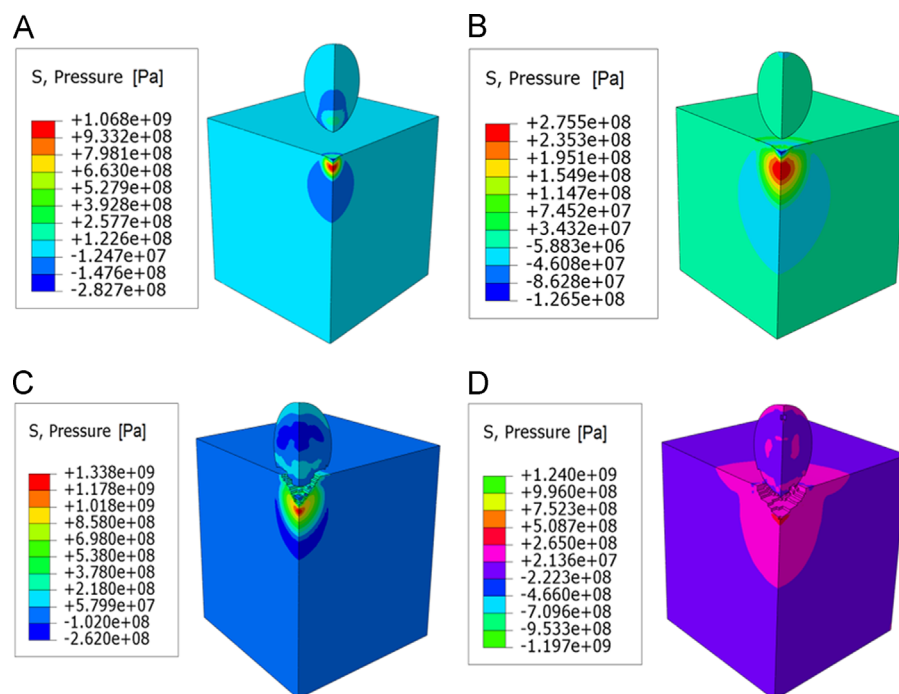
Impact of particles with initial velocities of 50–250 m/s, in steps of 50 m/s, was simulated for the two plate materials, Ti-6Al-4V and CP-Ti grade 1. The residual three-dimensional (3D) pressure distribution ($P = \sigma_{ii}/3$) at $t = 2.5 \mu\text{s}$, i.e. long after the transient impact effects, is shown in Fig. 10. The pressure distribution for the Ti-6Al-4V plate impacted at 50 and 250 m/s is shown in Fig. 10A and C, respectively. The results for the CP-Ti impacted at similar velocities are shown in Fig. 10B and D. A large zone underneath the impact location is subjected to a residual pressure (stress) because of the large plastic deformation of the substrate. A crater is formed underneath the impact location, as shown in Fig. 10A and B, even at the lower impact velocity of 50 m/s for both materials. The dimensions (depth and diameter) of the crater grow with increasing impact velocity. Both materials break and tear for impact velocities higher than 150 m/s, as shown in Fig. 10C and D.

Fig. 10 – Contour maps of residual pressure due to impact. A: Ti-6Al-4V plate at 50 m/s. B: CP-Ti plate at 50 m/s. C: Ti-6Al-4V plate at 250 m/s. D: CP-Ti plate at 250 m/s. Note that the region of positive residual pressure (compression) is much larger for the CP-Ti for both impact velocities.

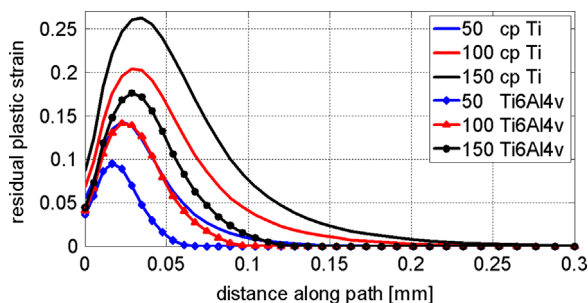
The residual equivalent plastic strain distribution along a vertical path is shown in Fig. 11 for impact velocities of 50, 100 and 150 m/s. The path starts at impact location and stretches to the bottom of the plate (Fig. 3A). The velocities affect the size of the region in which plastic residual strains exist and the strain distribution (shape and magnitude) within this region. A first characteristic parameter of the region is its length along the path. A second characteristic parameter, indicating the extent of the residual plastic strain within the region, is its peak value (since the distribution shape is similar for all velocities). It can be observed that the impact velocity has the same effect on the Ti-6Al-4V and the CP-Ti. Increasing the impact velocity causes the plastic region's length (along the path) to increase, and its peak values to grow. The peak value of the residual equivalent plastic strain in CP-Ti is $\sim 50\%$ higher than for the Ti-6Al-4V. The length of the plastic zone of the CP-Ti is ~ 2 times larger. Such residual strains are the essence of hardening surface treatments aimed at improving the fatigue life of a component.

Fig. 11 – Residual equivalent plastic strain distribution along a vertical path (shown in Fig. 3A) underneath the impact location for CP-Ti and Ti-6Al-4V impacted at 50, 100 and 150 m/s.

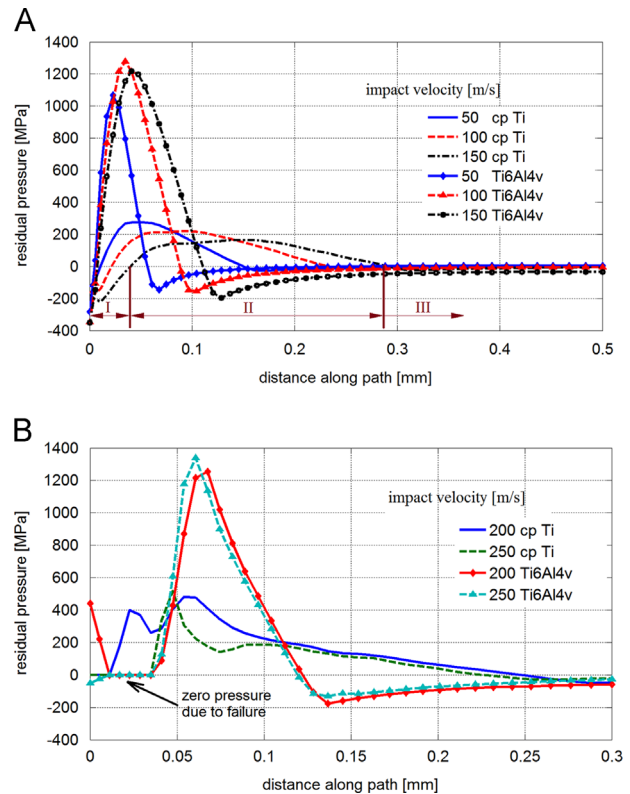
For the two materials, as shown in Fig. 12B, the tension region I no longer exists and is replaced instead by a zero

Fig. 12 – Residual pressure distribution along a vertical path (shown in Fig. 3A) underneath the impact location for CP-Ti and Ti-6Al-4V. A: impact at 50, 100 and 150 m/s. B: impact at 200 and 250 m/s.

pressure region. This is due to local fracture (ablation of material) that occurs at impact velocities exceeding 150 m/s.

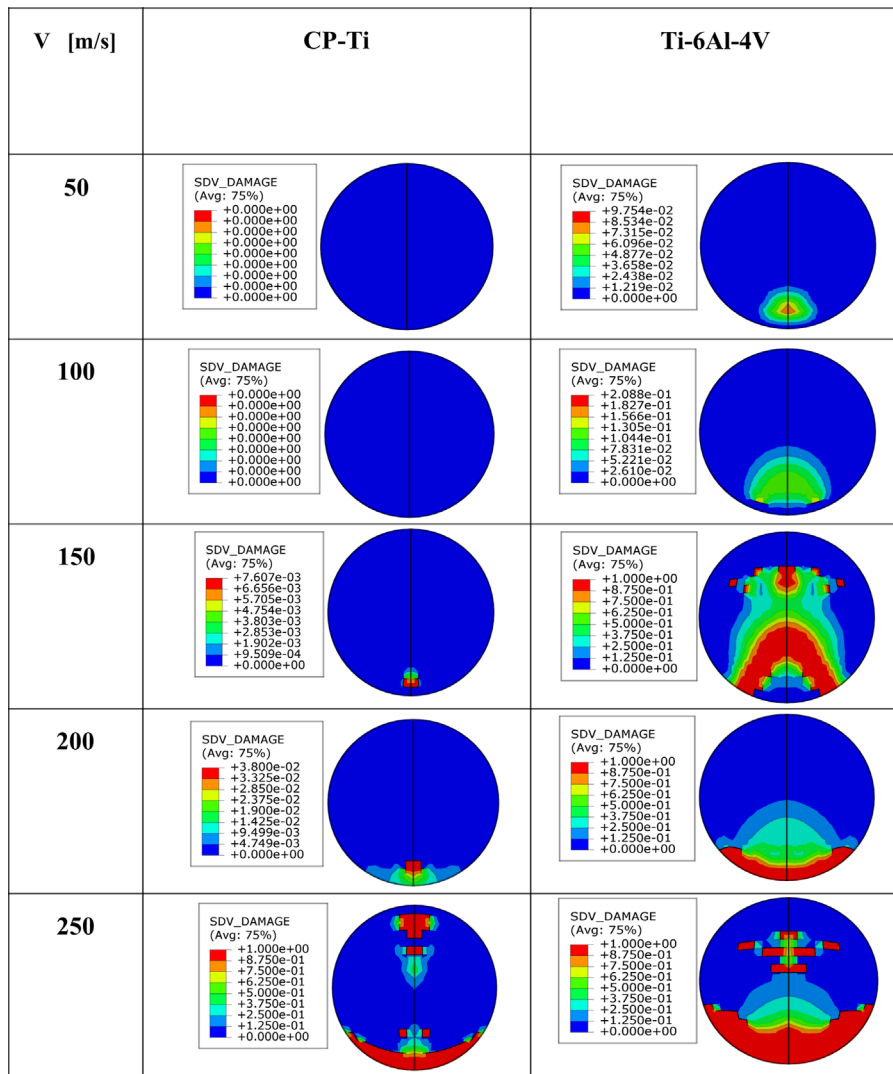
Fig. 13 shows that the ceramic sphere is already damaged at an impact velocity of 50 m/s when the substrate is made of Ti-6Al-4V, while with CP-Ti, damage starts only at 150 m/s.

**Fig. 13 – The damage in ceramic sphere at 2.5 μs after impact with the 2 plates at velocities ranging from 50 to 250 m/s. A value of 0 means no damage, while 1 means total damage.**

At 250 m/s the damage is much more widespread for the case of impact with Ti-6Al-4V. This result can be rationalized by noting that Ti-6Al-4V has a much higher hardness than CP-Ti.

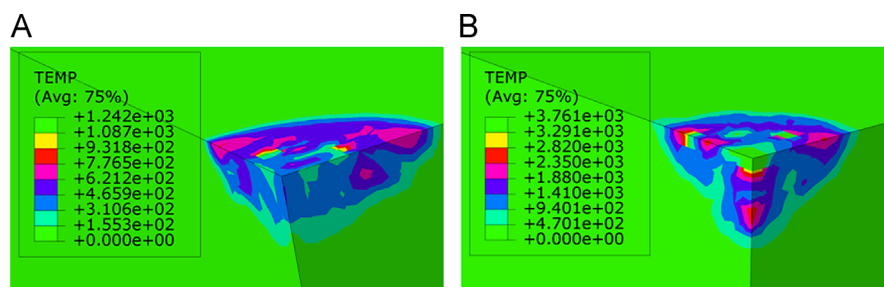
Table 3 shows that for the Ti-6Al-4V substrate impacted at velocities lower than 200 m/s, the temperature rise is moderate. As the impact velocity reaches and exceeds 200 m/s, the temperature rise is significant to an extent that the melting temperature is reached and even exceeded ($T/T_m \geq 1$). The melting phenomenon is likely to cause adhesion of some of the alumina debris to the impacted surface. By contrast, the temperature rise of the CP-Ti substrate is more moderate, but may nevertheless reach ($T/T_m = 0.54$), which is not negligible (Fig. 14).

Fig. 14 – Temperature rise map (in K) for a 250 m/s impact on: A. CP-Ti, B. Ti-6Al-4V.
